2016 Annual Environmental Report r01 –  
OCTP Phase 1

TITLE:			
2016 Annual Environmental Report r01 - OCTP Phase 1			
NOTE:			
DATE OF ISSUE:		EFFECTIVE DATE:	
16 May, 2017		16 May, 2017	
PREPARED BY:	CHECKED BY:	REVIEWED BY:	APPROVED BY:
Serwaa Akpene Anaglate HSE Engineer	Margarita Kuzmina Environmental Coordinator	Murad Khan HSEQ Manager	Ruiu Giancarlo Managing Director

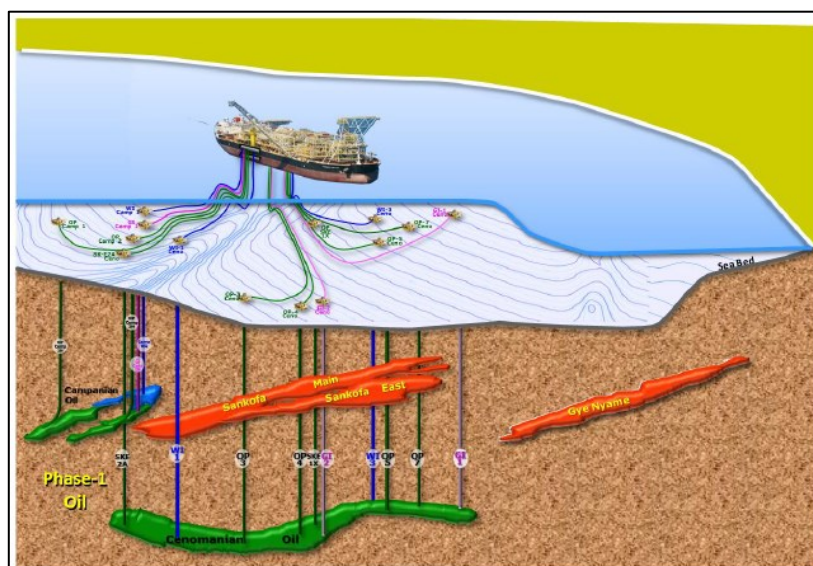
Figure 2: Schematic Layout-Phase 1

Wells drilled in 2016 were OP-7, WI-1, WI-3, SNK E-D, OP-4, OP-3, GI-3, SNK E-1X ST, SNK E-2A RE, SNK- 2AST 2, OP-6, OP-8 and SNK E-C. Drilling on OP-5 started in November 2015 and was completed in January 2016. Figure 2 illustrates the OCTP Phase 1 schematic layout.

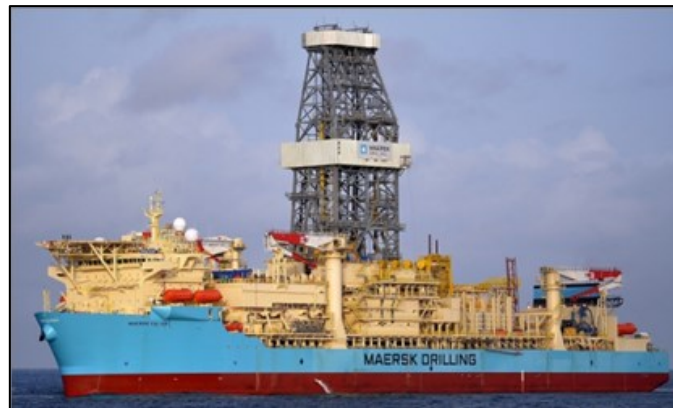
Figure 3: Maersk Voyager

The drillship, Maersk Voyager which started operations in July 2015, continued drilling in 2016 and will remain there until at least the 4<sup>th</sup> quarter of 2018. It is a double derrick dynamically positioned drilling ship. Its position and location is guaranteed by thrusters and GPS systems. A picture and a summary of the specifications of the drillship are provided in Figure 3 below and Table 2 below.

Name	Owner	Rig Type	Maximum Rated Water Depth (m)	Maximum Drilling Depth (m)
Maersk Voyager	Maersk	Drilling Ship	3, 657	12, 190

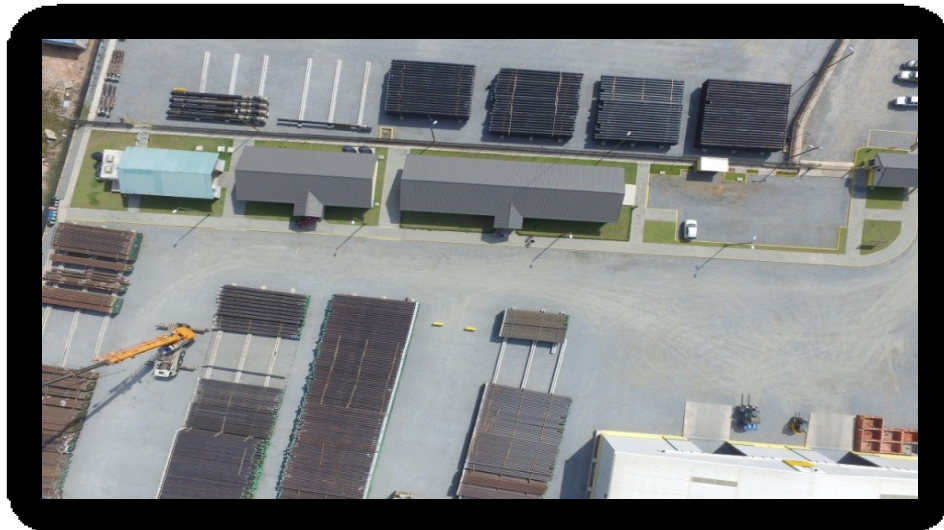
**Figure 4: Logistics Base**

The base consists of two yards and one building used as offices. It covers an area of 20,000 m<sup>2</sup> with 4,000 m<sup>2</sup> of warehousing facility, 15,000 m<sup>2</sup> used as pipe yard and 1,000 m<sup>2</sup> used as offices and other amenities (canteen and changing rooms). There is an additional pipe yard that covers an area of 10,000 m<sup>2</sup>. Casings and other materials such as mud mats, float shoe, mini containers, baskets and slings are stored in the warehouse. An aerial view of the logistics base is seen in Figure 4.

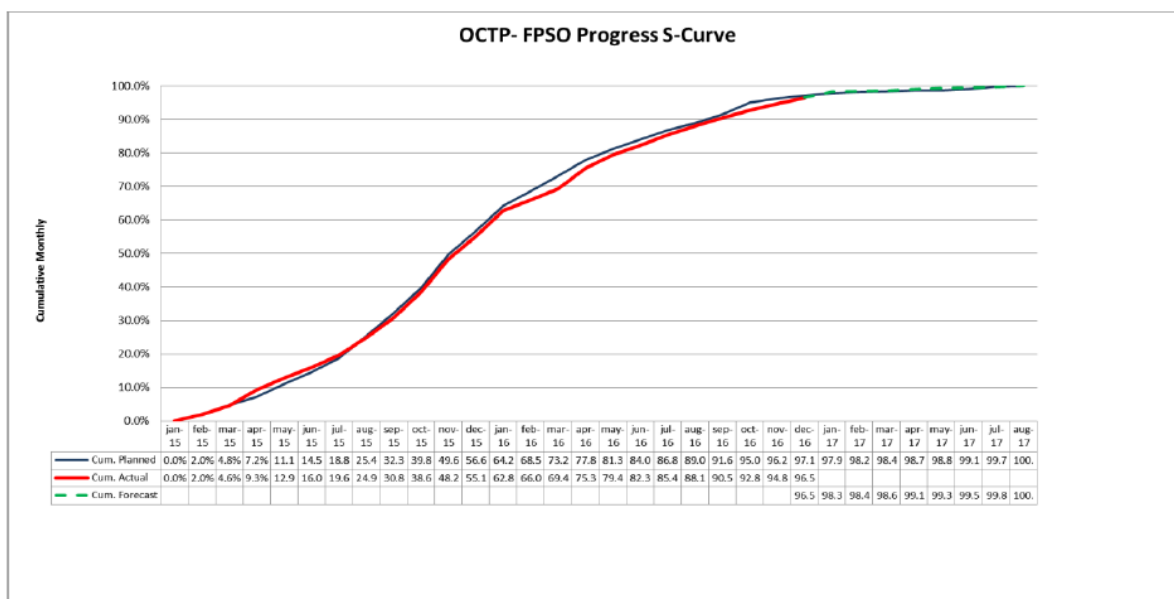
Figure 6: FPSO Progress Curve

FPSO hull conversion and repair works (China yard) were successfully completed in January 2016. The FPSO was transported to the Construction and Integration yard in Singapore in February 2016. All the modules were delivered to the Singapore yard and installed in the FPSO with the last module being installed at the beginning of September 2016. At the end of 2016, progress of topside modules completion was 100%. Construction and Commissioning works continued. Planned Sail away to Ghana is expected by Q2 2017. Figure 5 and 6 summarize the main milestone of the FPSO and the progress curve.

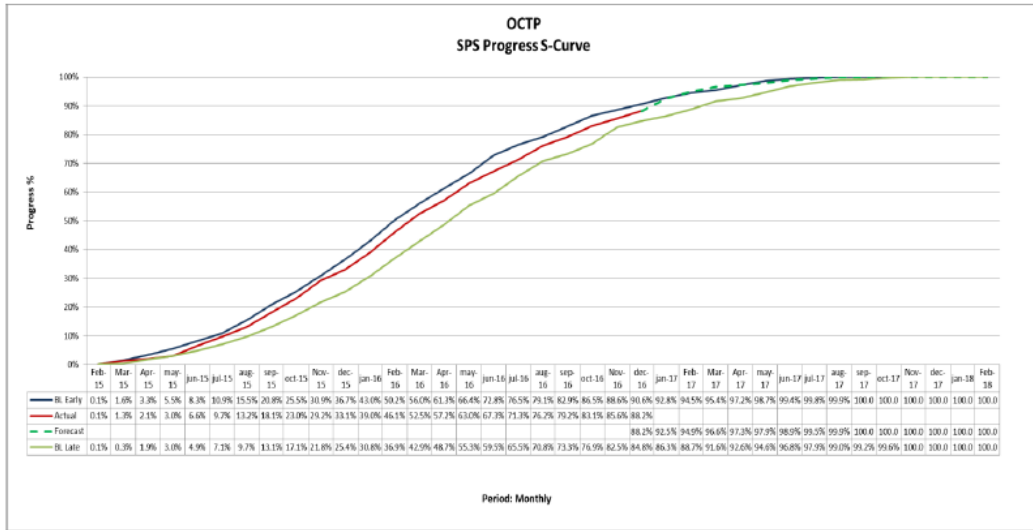
Figure 8: SPS Progress Curve

Figure 7 and 8 summarize the main milestone of the SPS package and the progress curve.

- Completion System progress was 87.4%;
- Control System actual progress was 81.9% as against a planned progress of 83.6%;
- Flowline End Termination (FLET), Subsea Isolation Valve (SSIV), Riser Base and Structure System actual progress was 91.4% against a planned progress of 99.6%;
- Actual progress of the Connection System was 94.3% vs. a planned progress of 100.0%;
- Actual progress of the Workover System was 99.2% vs. a planned progress of 100.0%;and
- Progress on the Umbilical System was 90.0%.

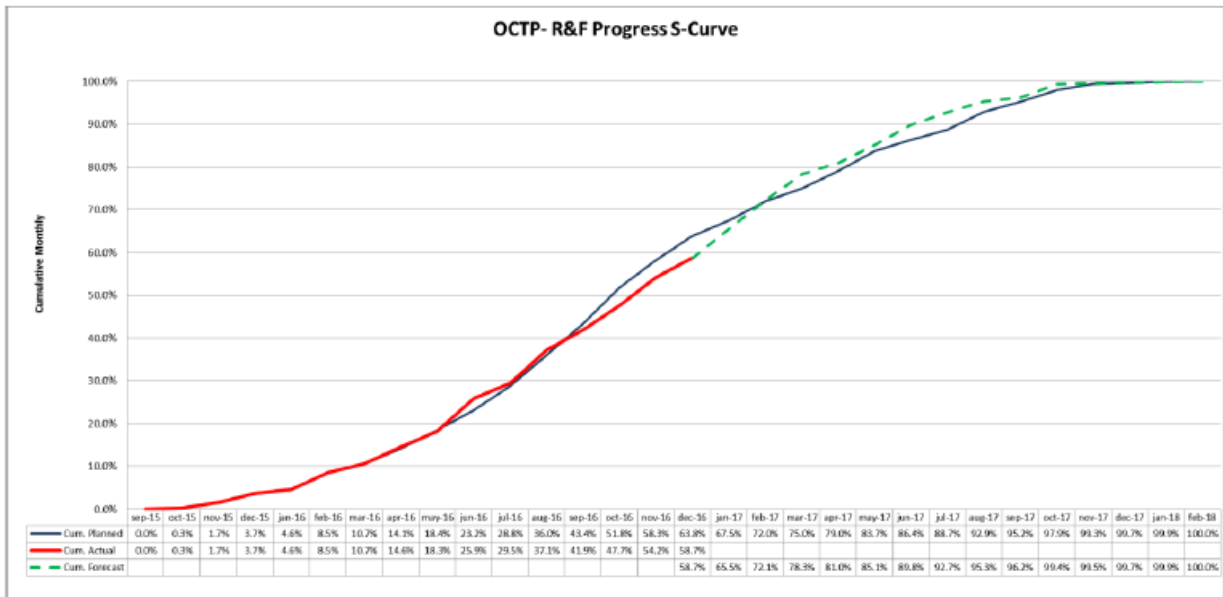
Figure 10: R&F Progress Curve

Engineering activities were slowed down by introduction of required additional items and modification of some already included in contract SoW (i.e. risers hold back clamps and anchors, counter flanges, automatic bend stiffener/automatic latching mechanism), in order to optimize the SURF installation activities. Final approval of some deliverables, part of the contract SoW, took longer than planned, due to the introduction of the new items. Figure 9 and 10 summarize the main milestone and progress curve of the risers and flowlines package.

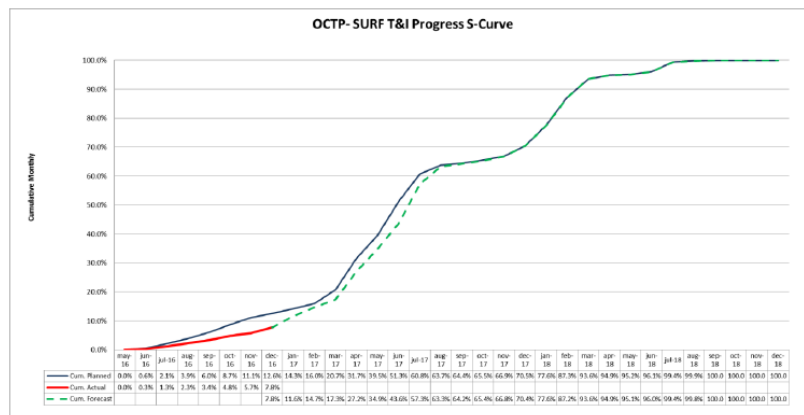
Figure 12: SURF Progress Curve

Base case schedule is considering the start of operations after the FPSO arrival at site and ready for SURF Hook by April 2017. A second option (the wet storage plan) is already under implementation by Contractor considering the possible delay of FPSO Sail away and consequently delay of arrival at site (maximum 1 month). The wet storage plan implies the start of installation activities before FPSO arrives on site, avoiding any impact of First Oil date. Figure 11 and 12 summarize the main milestone and progress curve of the SURF package.
