2016 Annual Environmental Report rev 01-  
OCTP Phase 2

TITLE:			
2016 Annual Environmental Report rev 01 - OCTP Phase 2			
NOTE:			
DATE OF ISSUE:		EFFECTIVE DATE:	
16 May, 2017		16 May, 2017	
PREPARED BY:	CHECKED BY:	REVIEWED BY:	APPROVED BY:
Serwaa Akpene Anaglate HSE Engineer	Margarita Kuzmina Env. Coordinator	Murad Khan HSEQ Manager	Ruiu Giancarlo Managing Director

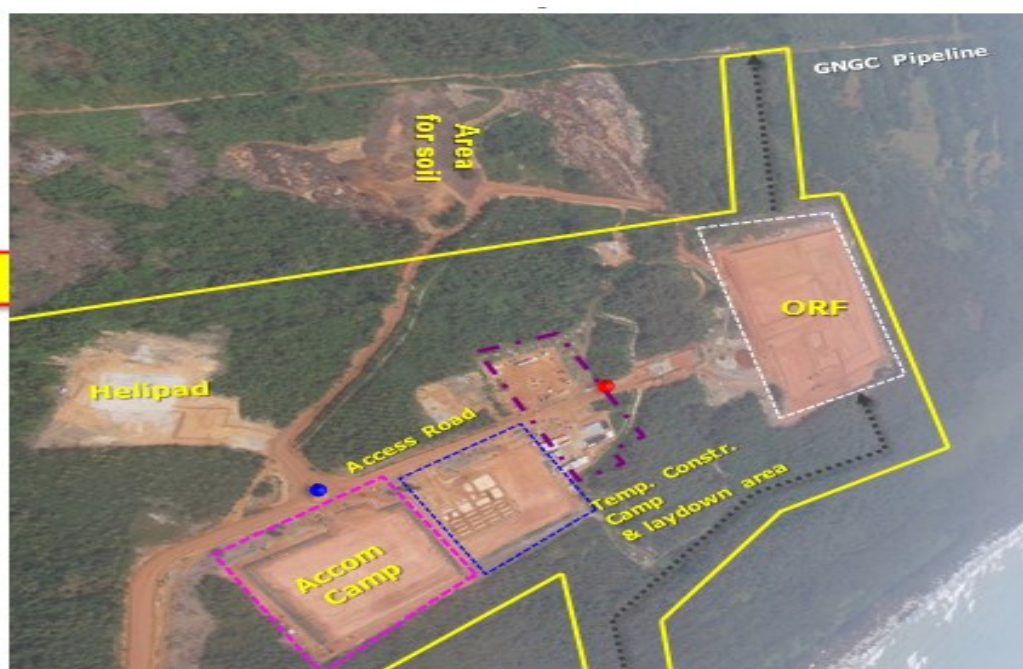
Figure 2: Overview of ORF

- Hauling of laterite to for filling at the ORF, Permanent Accommodation camp, Helipad, Pilot Camp, Laydown area, Water Wells, main access road;
- Spreading and compacting of laterite at the ORF, Permanent Accommodation camp, Helipad, Pilot Camp, Main access road, Laydown area, Water Wells;
- Civil works at the Pilot camp. (Foundation for camp cabins, drains, fence post erection);
- Fencing of Permanent accommodation camp, Temporal Site Facility (TSF), Water Wells, Pilot Camp, Laydown Area and ORF;
- Construction of culverts;
- Laying of service lines from Water Wells to the TSF;
- Laying of Fiber Optic Cable by Vodafone to the site.

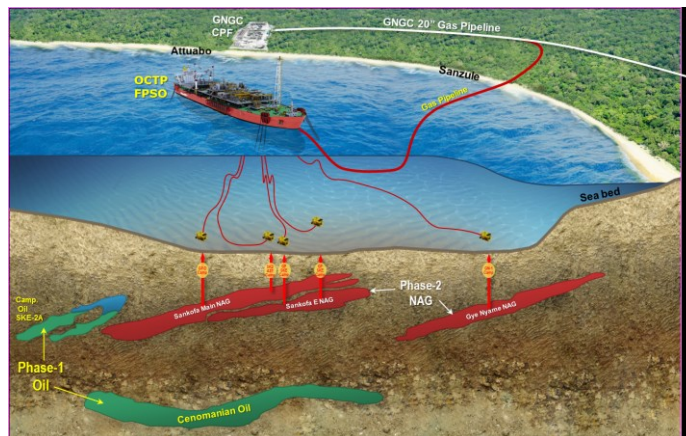
**Figure 3: Schematic Layout-Phase 2**

The drillship used was the Maersk Voyager. Figure 3 illustrates the OCTP Phase 2 schematic layout.

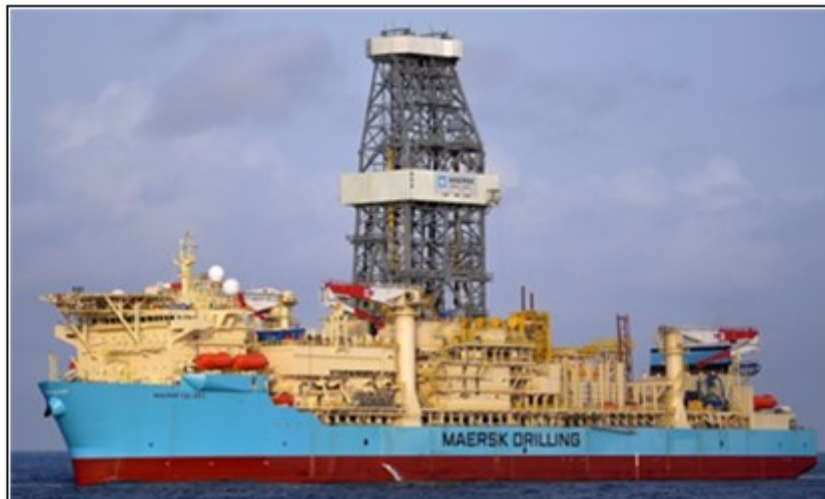
**Figure 4: Maersk Voyager**

The drillship, Maersk Voyager which started operations in July 2015, continued drilling in 2016 and will remain there until at least the 4<sup>th</sup> quarter of 2018. It is a double derrick dynamically positioned drilling ship. Its position and location is guaranteed by thrusters and GPS systems. A picture and a summary of the specifications of the drillship are provided in Figure 3 below.

Name	Owner	Rig Type	Maximum Rated Water Depth (m)	Maximum Drilling Depth (m)
Maersk Voyager	Maersk	Drilling Ship	3, 657	12, 190

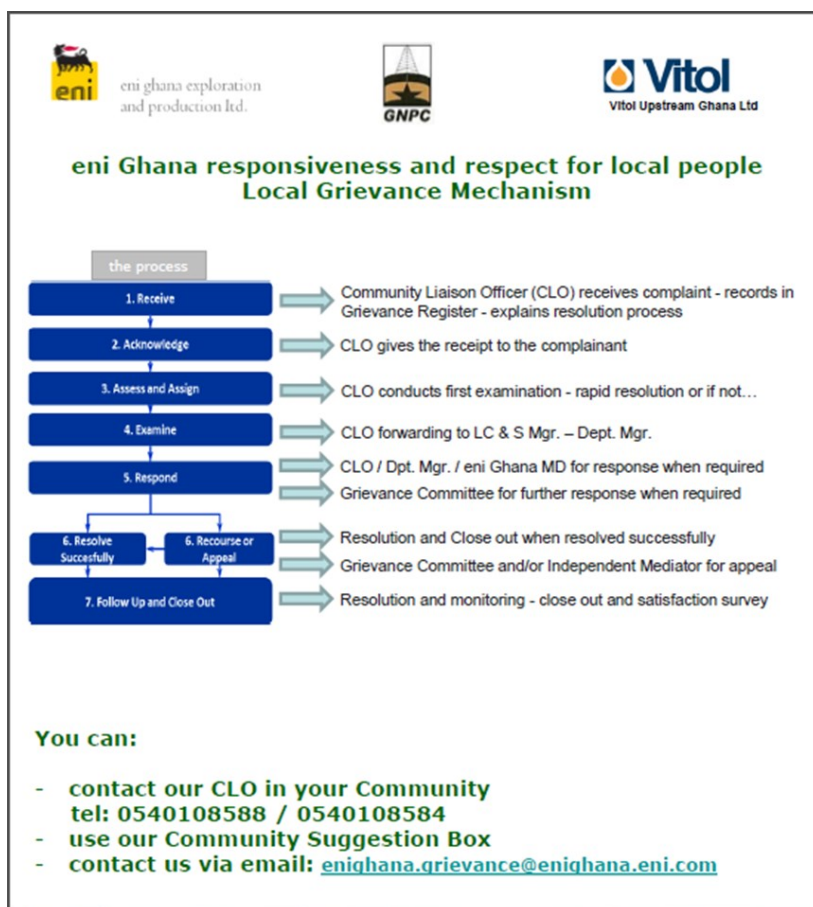
Figure 6: Grievance Mechanism

Eni Ghana has in place a grievance mechanism. Project-related grievances (written and verbal) received from communities and stakeholders affected at by the project were evaluated and addressed. The CLOs received and examined complains and provided rapid responses to the complainant. In instances where the CLOs could not resolve grievances, the grievances are escalated to the Local Content & Sustainability Manager to further handle the issue. The Grievance Committee is brought into the grievance management only when grievances are escalated at the Managerial level. Figure 5 shows the Grievance mechanism employed in Eni Ghana.

In 2016, about twenty-two (22) grievances regarding the Phase 2 project were received from complainants. All complaints were processed immediately they were received. As at December 2016, all complaints had been closed. All the grievances were closed out at CLO and or management level. No grievance was escalated to the Grievance Management Committee.
