## 2017 Annual Environmental Report - OCTP Phase 2

2017 Annual Environmental Report - OCTP Phase 2

03 April, 2018

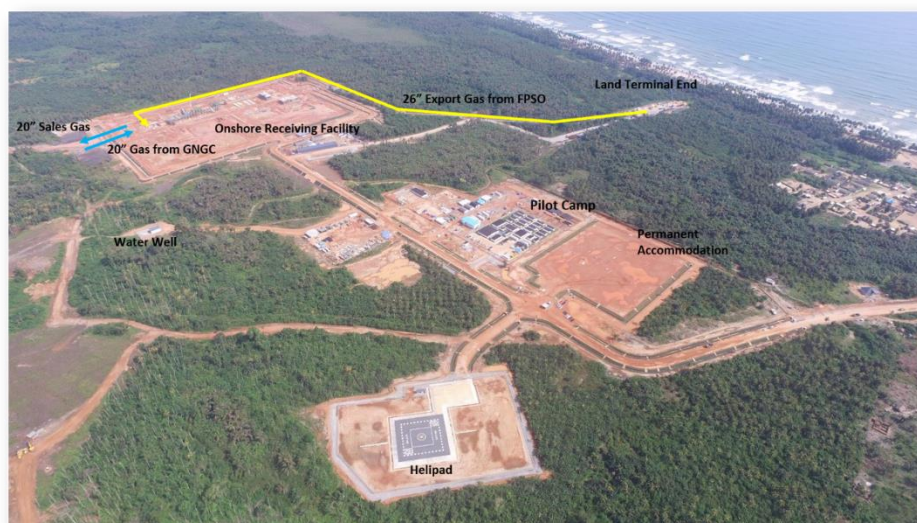
Figure 2: Overview of ORF

First gas is expected within 2Q 2018. Figure 2 below shows the current status of the ORF.

The Early Works were completed and the EPIC Contractor, Technip mobilized at site in January 2017. Civil work and piperack and steel structures erection were started and remain ongoing, electrical works started in December 2017. Compressors for Train 1 and 2 were delivered at site respectively on 15th November 2017 and 24th September 2017, both already installed on relevant foundations. Train 3 compressor was delivered to Siemens in the Netherlands for skid assembly, planned to be at site in July 2018.

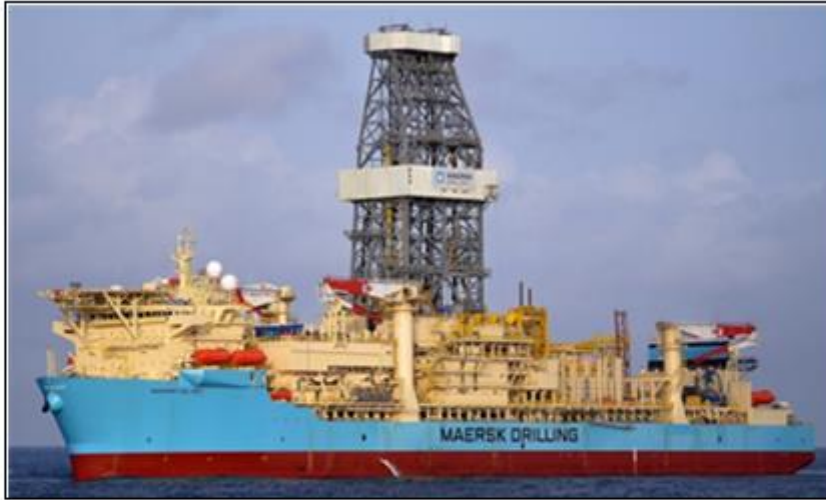
Figure 4: Maersk Voyager

The drillship, Maersk Voyager which started operations in July 2015, continued completion activities in 2017. It is a double derrick dynamically positioned drilling ship. Its position and location is guaranteed by thrusters and GPS systems. A picture and a summary of the specifications of the drillship are provided in Figure 4 below.

Name	Owner	Rig Type	Maximum Rated Water Depth (m)	Maximum Drilling Depth (m)
Maersk Voyager	Maersk	Drilling Ship	3, 657	12, 190

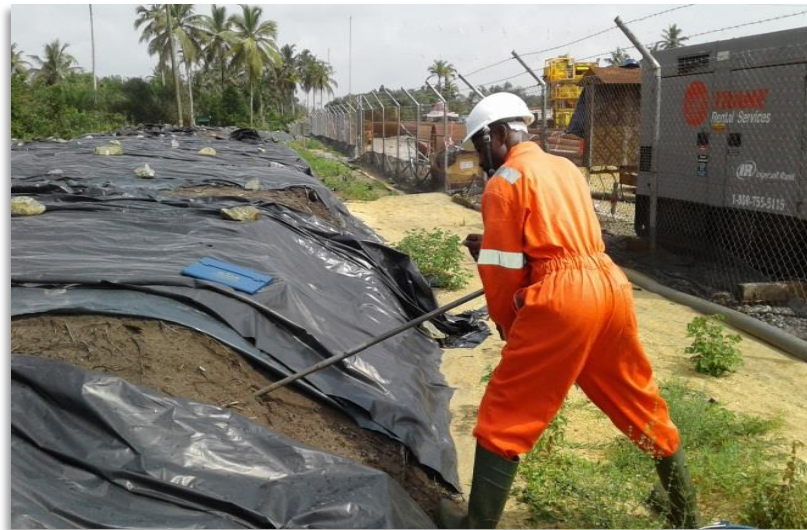
Topsoil condition were monitored to ensure suitability for reinstatement as well as assess the potential evolution of erosion sources and processes, and to observe and record loss of natural vegetation and habitats in the Project area. The figure below shows monitoring activities being done on the topsoil.

**Figure 7: Topsoil Management**
